## HUMAN FACTORS IN ACCIDENTS OF AIRSHIPS

**Abstract** Airships represent a type of transport vehicle possessing great potential for the development of various branches of industry. They can provide probably the greatest comfort in transporting passengers in relation to all other means of transport, which makes them particularly suitable for different tourist arrangements. However, today the use of airships is almost inversely proportional to their capabilities and the potential they have. One of the reasons for such a situation is certainly the safety aspect of airships. The unfortunate cases from the past have largely affected the demand for this type of transport. This paper aims to investigate to what extent the human factor was the reason for the occurrence of accidents with airships. Based on the insight into the literature and documentation related to accidents of airships, it can be concluded that the human factor did not have a large share in the occurrence of accidents involving this means of transport. However, the prevention of accidents in the future requires a more complex ergonomic analysis that should include a segment of human factors in all parts of the system th

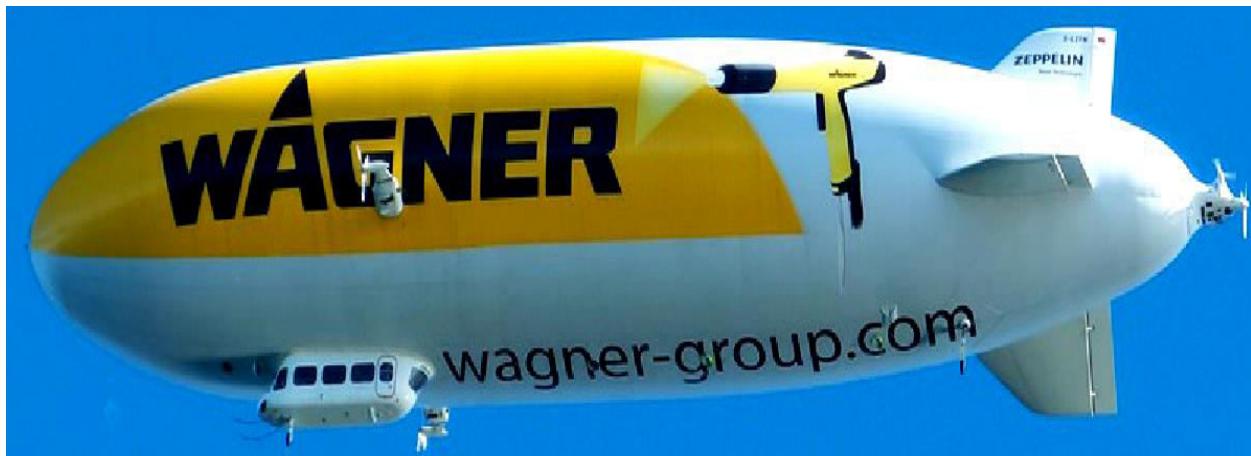
The possibilities of using airships are extremely high. They can be used for tourist purposes, research purposes, as well as for advertising (Figure 1). They were also used in military operations. These aircrafts can offer extremely high comfort to passengers. For example, the Hindenburg airship owned: a big dining room, a passenger lounge with carefully designed furniture and a piano, a writing room, 34 passenger cabins for sleeping, male and female toilets, a shower, promenades with seating areas and large windows which could be opened in flight, a smoking room, a bar, etc.

**Figure 1. An example of the use of airships.**
