IDENTIFICATION OF HAZARDS AND RISK ASSESSMENT FOR THE WORKPLACE OF MAINTENANCE WORKER OF A BUCKET-WHEEL EXCAVATOR - CASE STUDY

Abstract The subject of this paper is the identification of hazards for the workplace of the maintenance worker bucket-wheel excavator SRs 1200x24/4, as well as the risk assessment for that workplace. In addition to the hazards arising from the design of the machine itself, ergonomic hazards have been identified, as well as hazards arising from the working environment. The HRN (Hazard Rating Number) method was used to assess the risk. The emphasis of the paper is on the comparison of the original HRN method with two modifications of this method. The mentioned modifications refer to the tabular values of the influencing factors used in the risk assessment. It was concluded that the original HRN method still represents a solid basis that allows its application in practice for risk assessment.

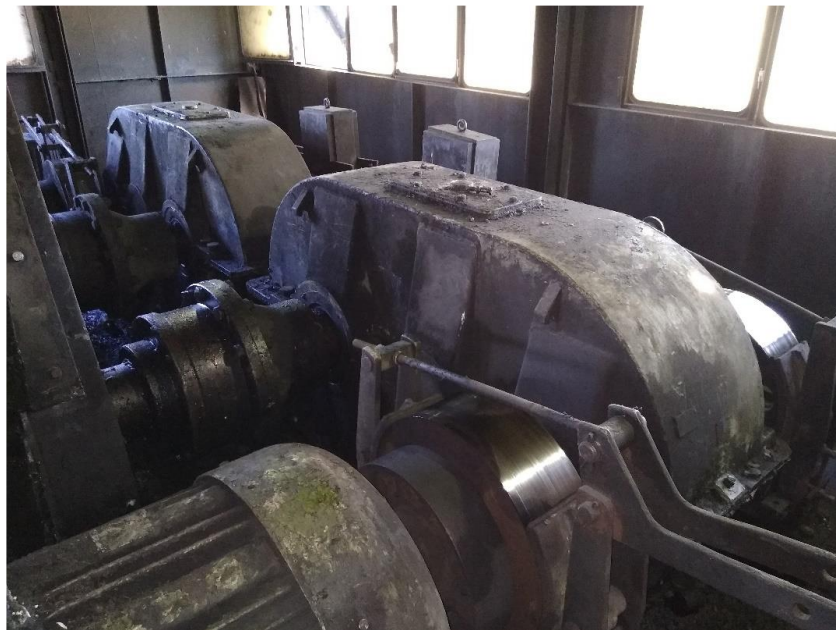
Figure 1. Rotating parts of the excavator.

The regular production process requires the maintenance worker to control the operation of machine assemblies throughout the excavator, as well as to eliminate minor defects. The results obtained on the basis of the application of the observation and interviewing methods will be presented here. Figure 1 shows the excavator's rotating parts, which are under the supervision of the maintenance worker.

Among other things, the maintenance worker monitors the condition of the reducer coupling and brake linings on a daily basis, and on that occasion, injuries can occur due to the close proximity of the rotating parts. Rotating parts have their own protection. However, in order to diagnose a fault, this protection is often removed while the machine is running, which is hazardous.

Ergonomic hazards related to inaccessibility can be seen in figures 2 and 3. In addition, Figure 1 also shows parts that are very difficult to access. Due to the existence of poorly accessible locations, the worker often has to take an inappropriate body position. In addition, tripping, slipping and falling on hard-to-reach parts are possible.

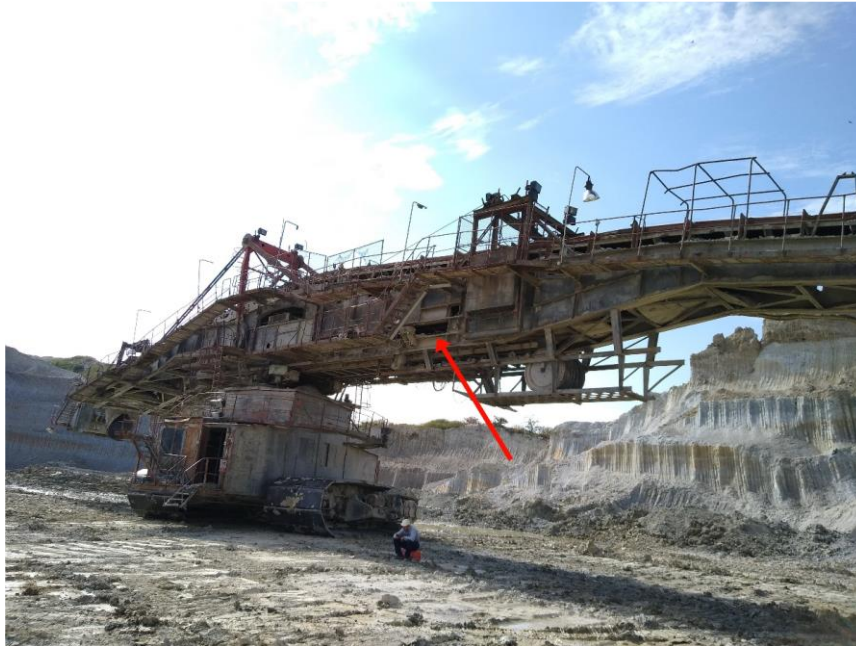
Figure 2. Opening of the chamber of the propulsion part intended for lifting the break part of the unloading lane.

Figures 2 and 3 show the position of the opening of the chamber of the drive part intended for lifting the breaking part of the unloading strip (marked by an arrow) and the entrance to that chamber.

In the event of the need to replace the reducer unit (weighing approx. 35 kg), the crane can only lift the reducer unit to the approach to the chamber opening (Figures 2 and 3). Further manipulation of the reducer is performed by a maintenance worker. The reducer must first be inserted into the chamber through the said opening. That opening is the only opening for human entry (in this case maintenance

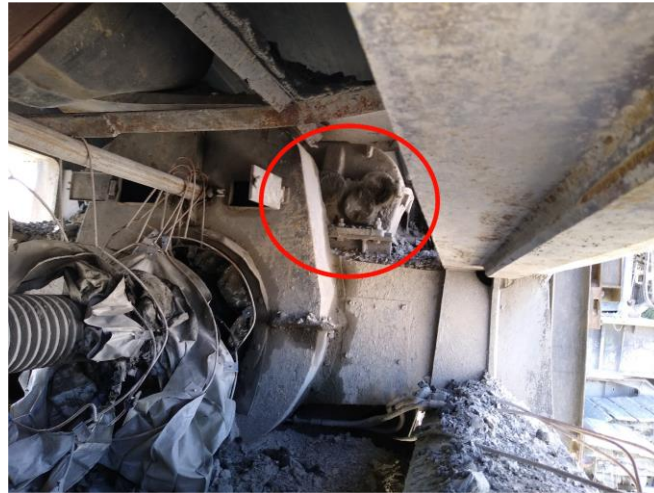
Figure 4. Interior of the chamber and position of the machine reducer.

workers). After the reducer unit is in the chamber, the maintenance worker should raise the reducer unit to a height of approx. 1 m (Figure 4). The same reducer must be moved during regular maintenance and inspection.

Due to the manipulation of a load of heavier weight in a cramped space, in addition to inadequate body position, the maintenance worker is exposed to an effort of greater intensity, which is also a hazard. In addition, the maintenance worker is exposed to dust (Figure 5), noise and vibration.
